Report No. CG-WEP-2-79

FATE OF OIL SPILLED FROM THE  
SUPERTANKER METULA

JANUARY 1979

FINAL REPORT

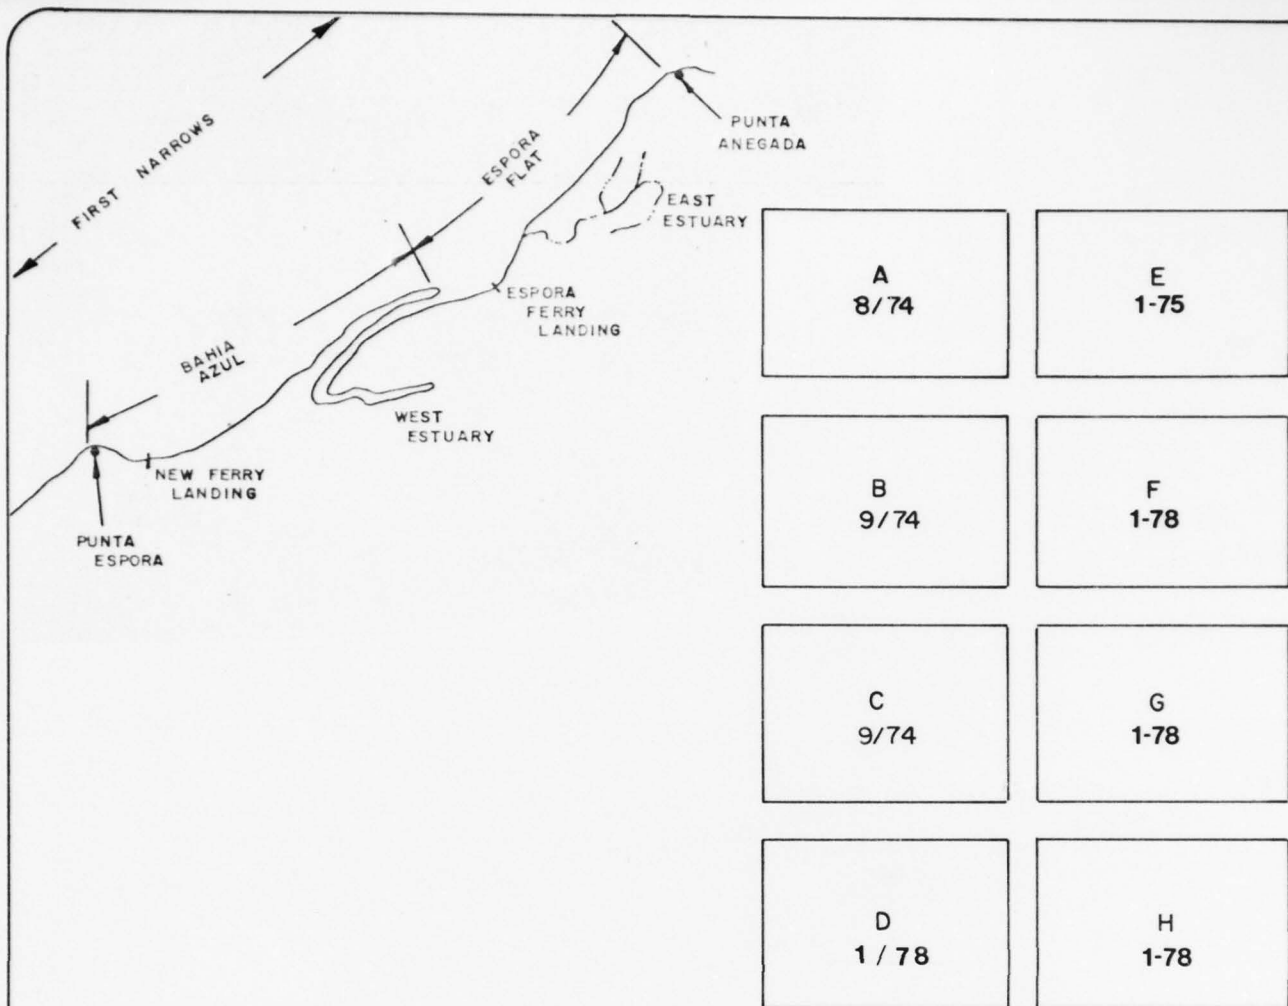
FIGURE 25

Pictures of the tidal flats in this area taken in September 1974 had shown oil at the high tide zone and only a light coating of mousse on the rocks of the tidal flats in some areas. The pooling of considerable oil in this area following the strong southwest wind of September 2, 1974 was noted and photographed during the initial field study.

- A - Espora flat in late August 1974.
- B - Movement of oil into Espora area on September 2, 1974.
- C - Deposited oil in Espora Flat at low tide on September 2, 1974.
- D - Algae on oil surface and mousse under surface.
- E - Oiled sediment in Espora Flat on January 1975.
- F - Oiled sediment in Espora Flat in January 1978.
- G - Oiled Espora tidal flat looking seaward.
- H - Close-up of algae growing on oiled sediment.

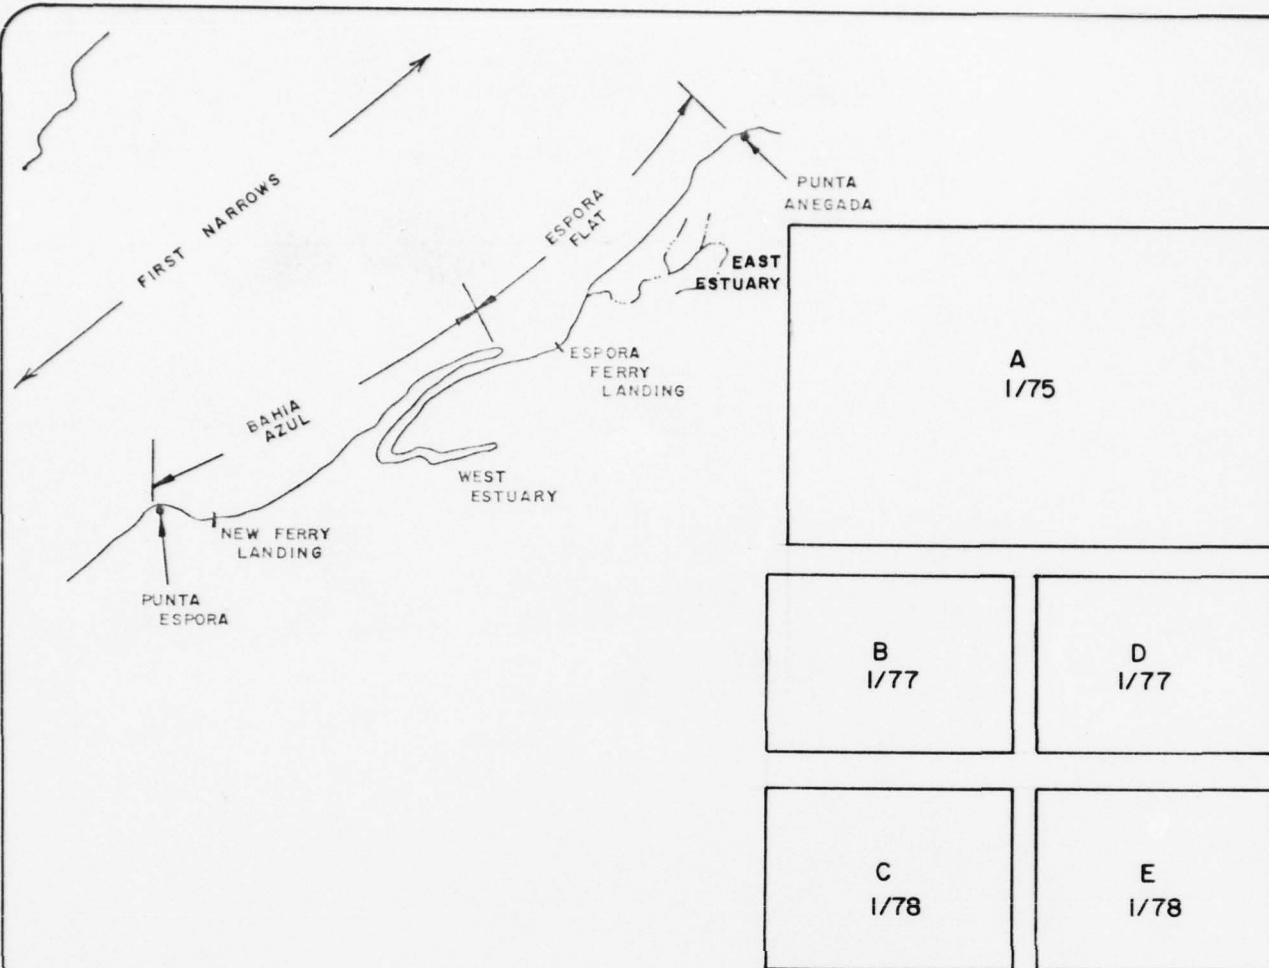
FIGURE 26

The dramatic aerial extent of the deposits may be noted in Figure 26 Part A and the depth of the pavement-like moussecrete may be noted in Figures 26 Parts B, C, D and E. These latter pictures were taken in 1977 and 1978 where the edges of the pavements are eroding.

- A - View along oiled tidal flat toward Old Ferry landing.
- B - Eroded edge of sediment at bottom of beach slope.
- C - Close-up of eroded edge showing 11 inch thickness.
- D - Additional close-up of eroded edge taken in January of 1978.
- E

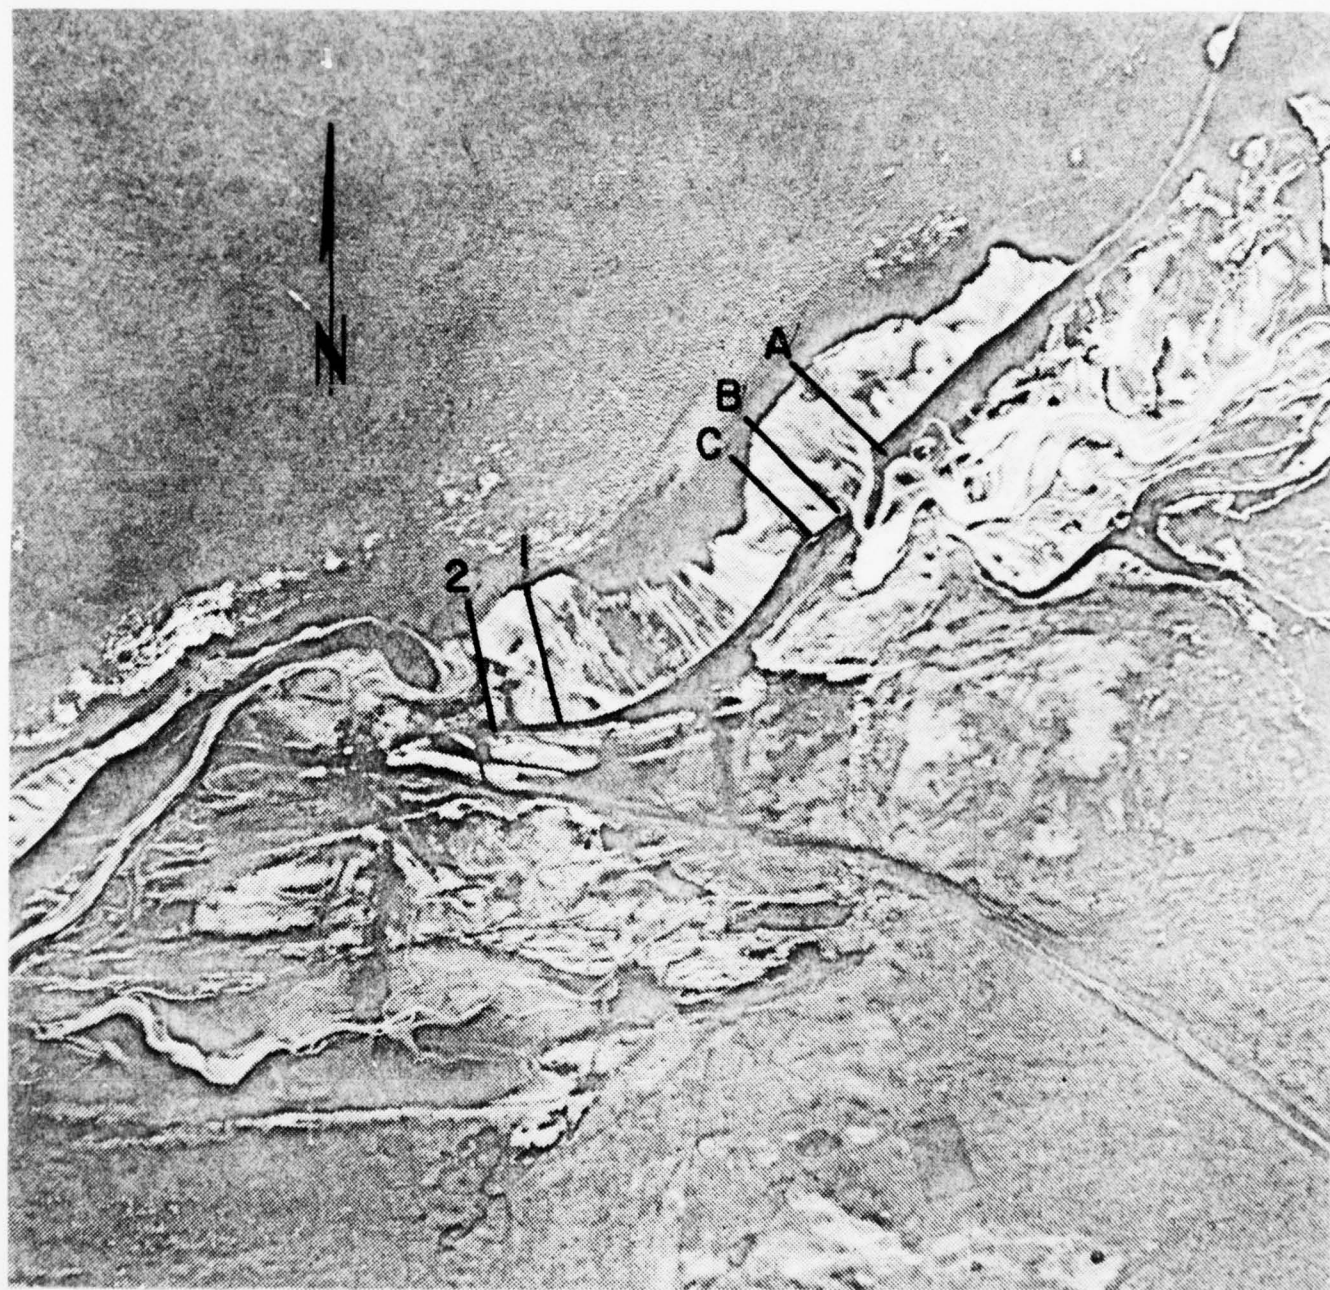
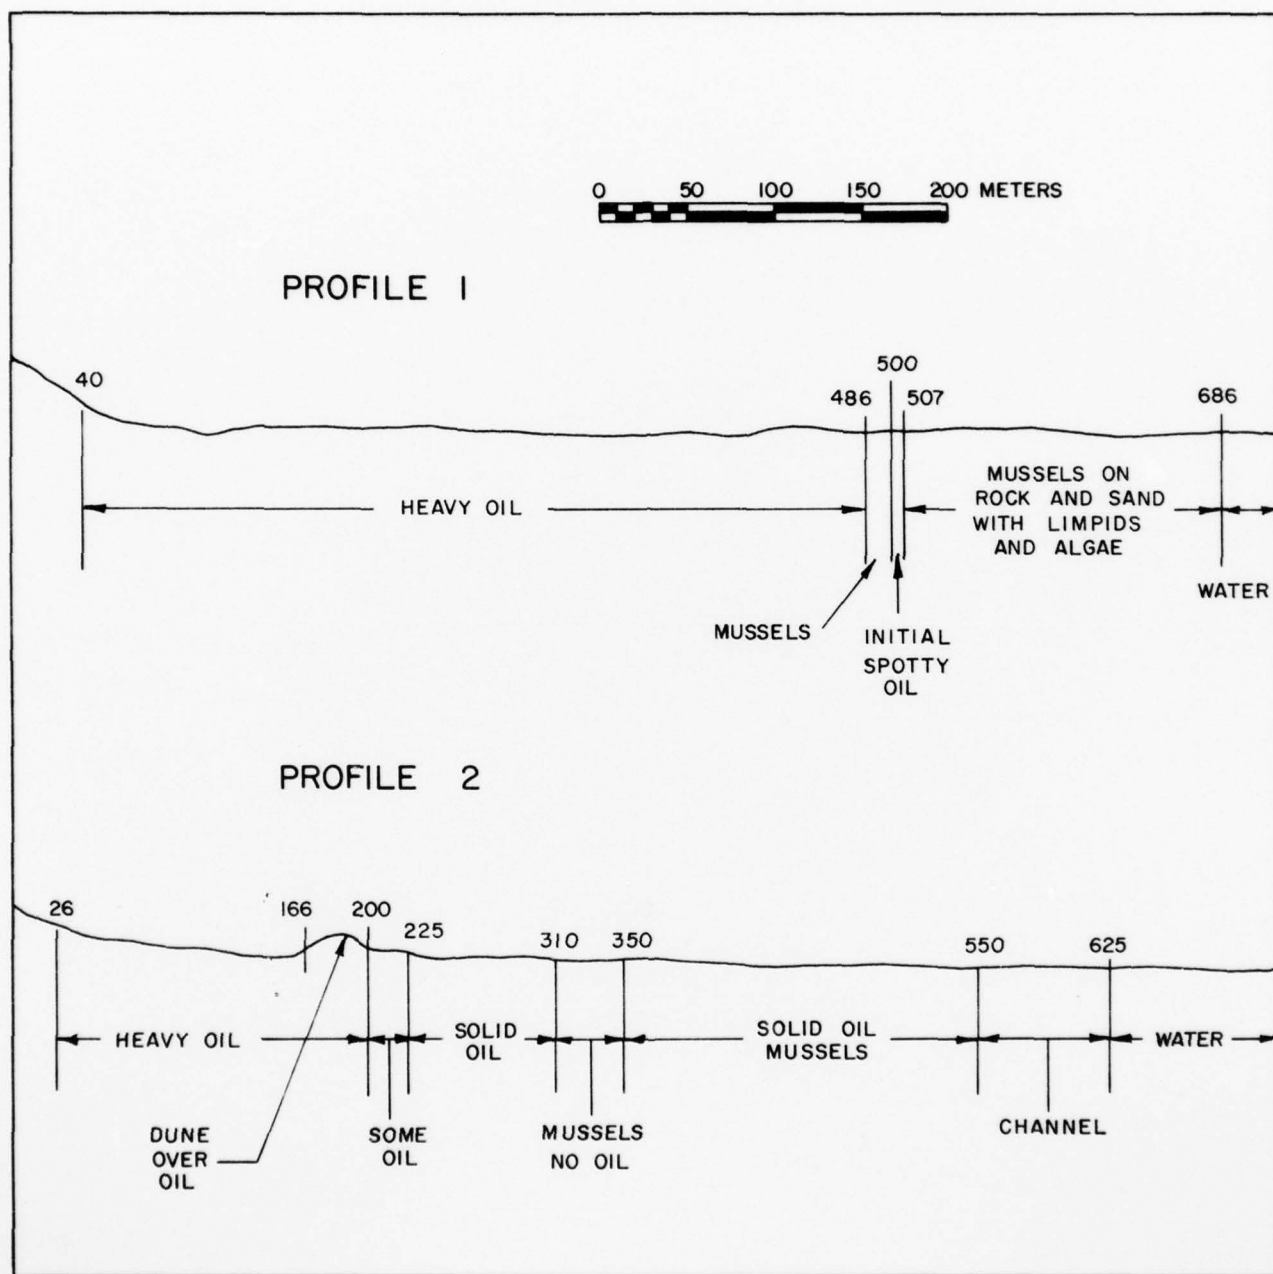
FIGURE 27  
BEACH PROFILE ESPORA FLAT NEAR ENTRANCE OF WEST ESTUARY

Figures 27 and 28 show five profiles made across the Espora Flat in 1977. It may be noted that the oiled zone ranged from over 300 meters to 600 meters (110-220 ft) wide.

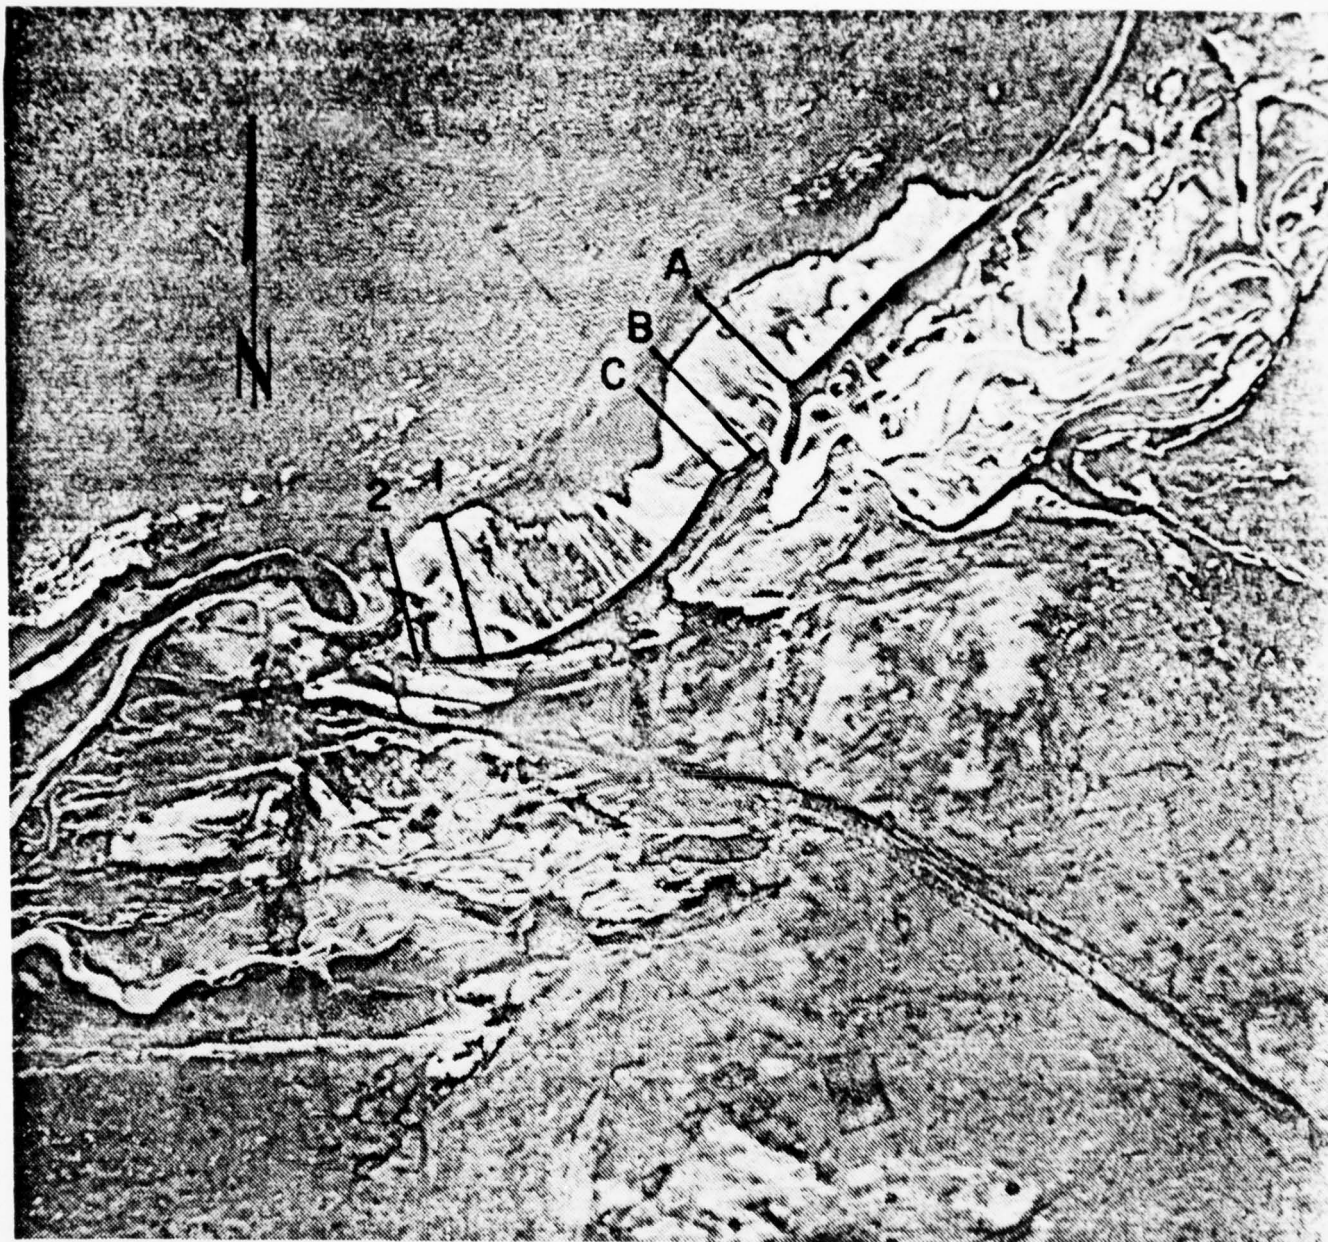
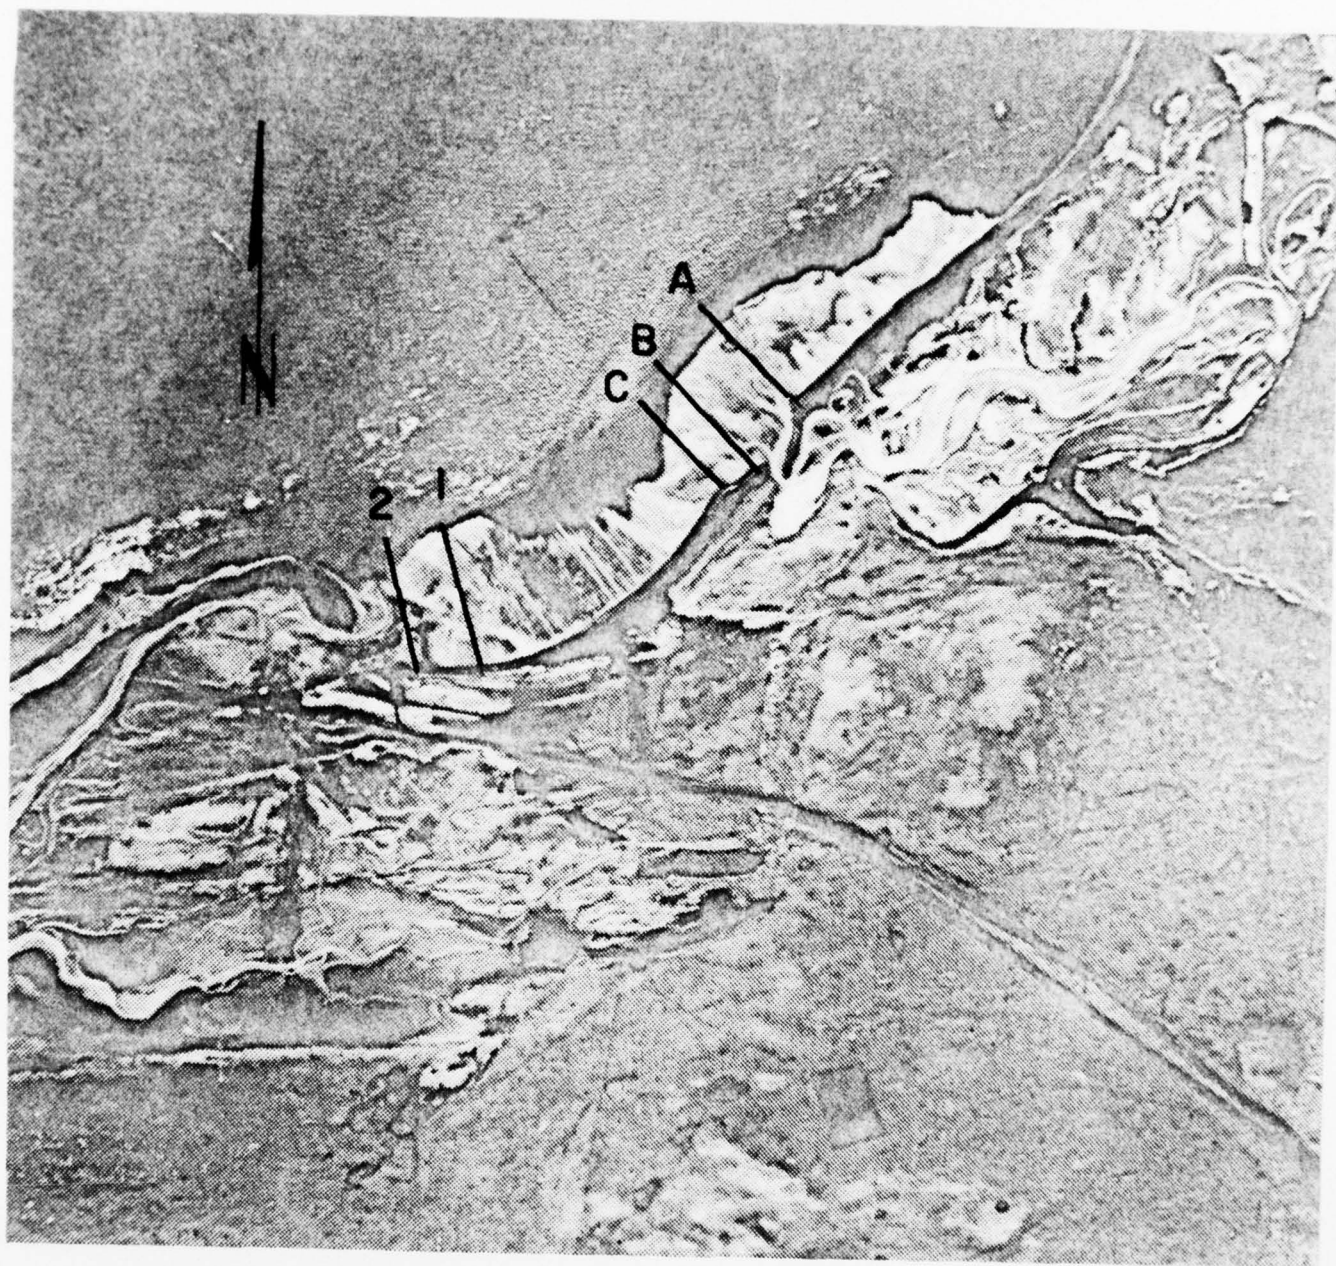
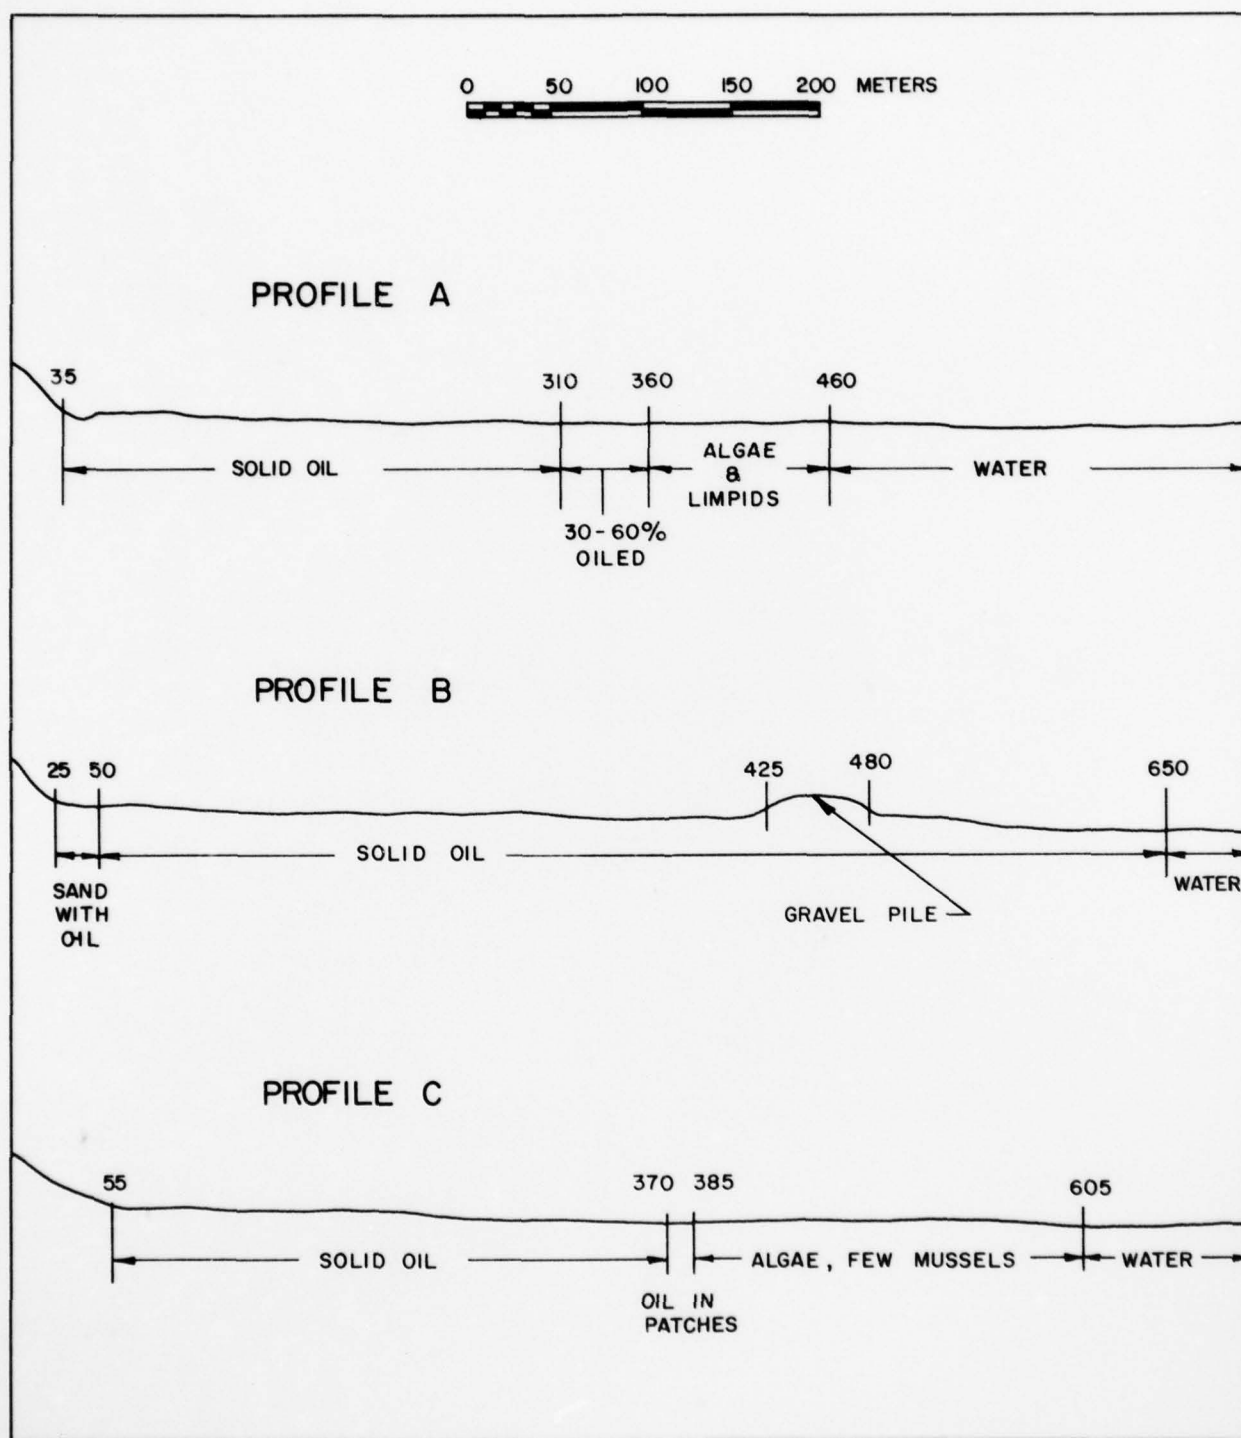
FIGURE 28  
BEACH PROFILE ESPORA FLAT NEAR ENTRANCE OF EAST ESTUARY

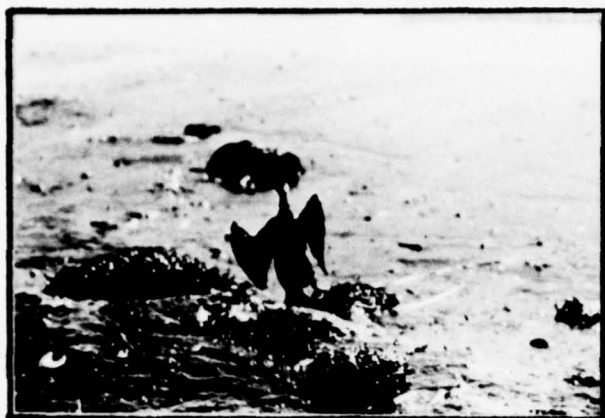
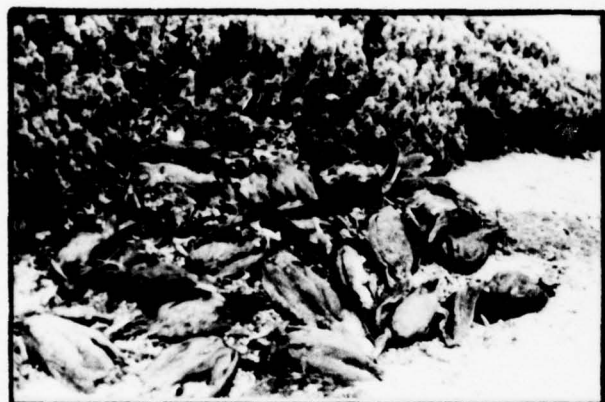
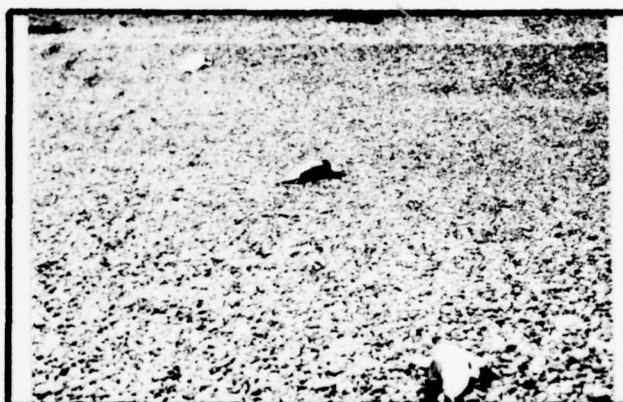
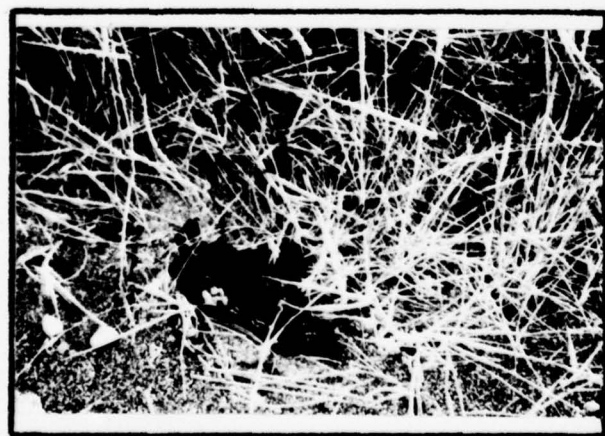
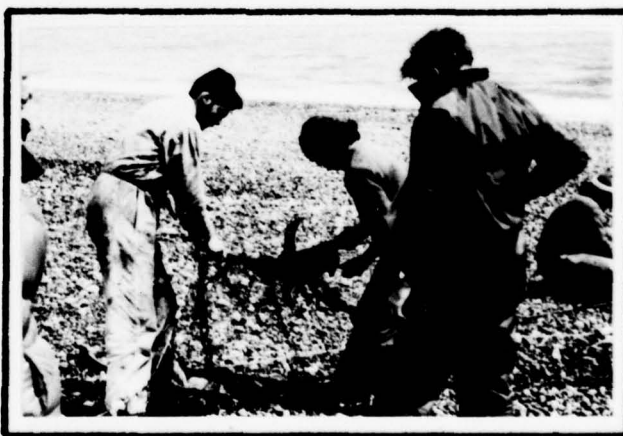
FIGURE 42

- A - Oiled Cormorant near Punta Espora.
- B - Group of 22 dead cormorants found within a 15 meter radius east of Punta Anegada.
- C - Oiled dead Penguin.
- D - Oiled Penguin.
- E - Oiled dead Penguin.
- F - Oiled dead Penguins near Punta Dungenes.
- G - Penguins trapped in fish nets near Punta Dungenes.
- H - Close-up of oiled dead Penguins killed in nets.
